TROUBLESHOOTING YOUR RIFLE and SHOTGUN

By J. B. Wood

**Do-it-Yourself
Diagnosis and Repair
for Rifles and Shotguns**

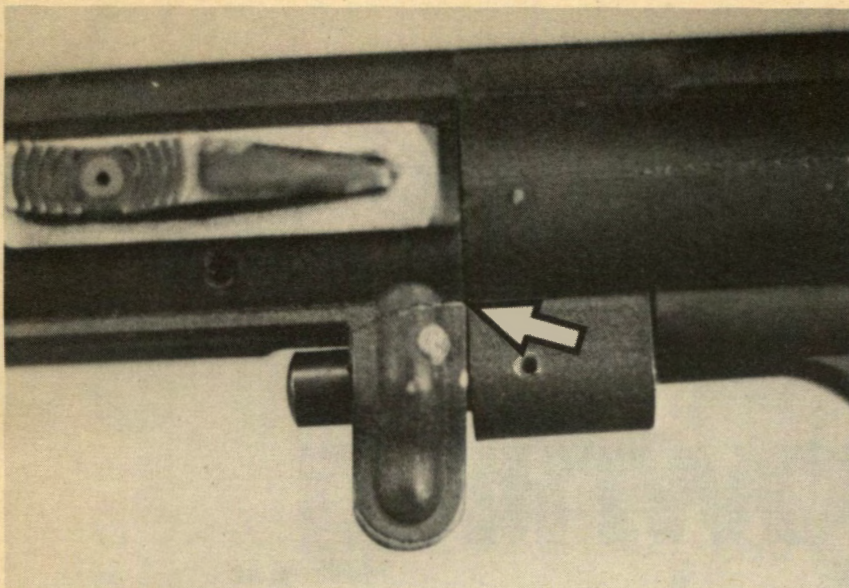
The barrel pivot-handle, which also serves as part of the barrel-latch system, tends to crack (arrow) with *rough* usage. Note the repair pin just below the crack.

It is possible to repair a cracked handle by drilling a slanted hole and cross-pinning the cracked parts in place, but this is not a job for the amateur, as the hole will come perilously close to the chamber area of the barrel. The gun shown in the photos has had this repair and has seen quite a bit of use since this was done. In some cases, though, this repair may not be possible, depending on the pattern of the break.

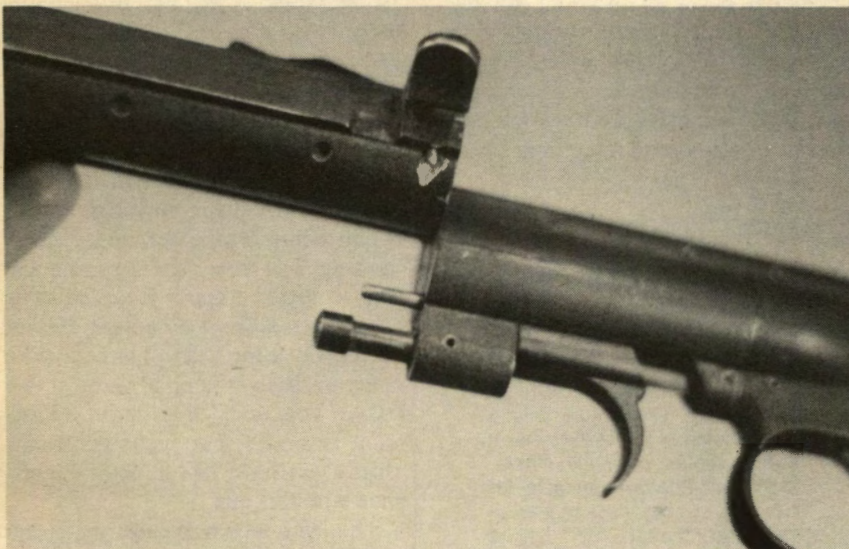
With the barrel pivoted to loading position, the barrel latch plunger and stud can be seen. Note also the end of the repair pin, just below the pivot-handle.

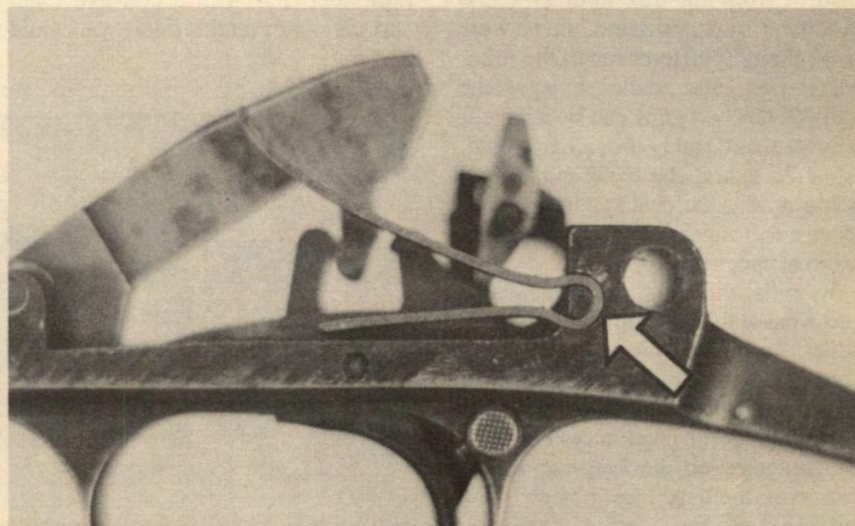
A blade-type carrier spring (arrow) is keyed into the trigger housing. These do not break often, but are susceptible to weakening.

The carrier spring is a flat type, V-shaped, with a keyhole-bend designed to fit over a stud in the receiver on the older guns, and into a recess in the trigger housing on later pieces. The carrier itself is also different on early and late models, being a single part on the older guns, and a two-part assembly on late ones. The spring occasionally breaks, but more often, on very old guns, it loses some of its tension, failing to return the carrier with sufficient snap for rapid feeding. Replacement of this spring is extremely simple.

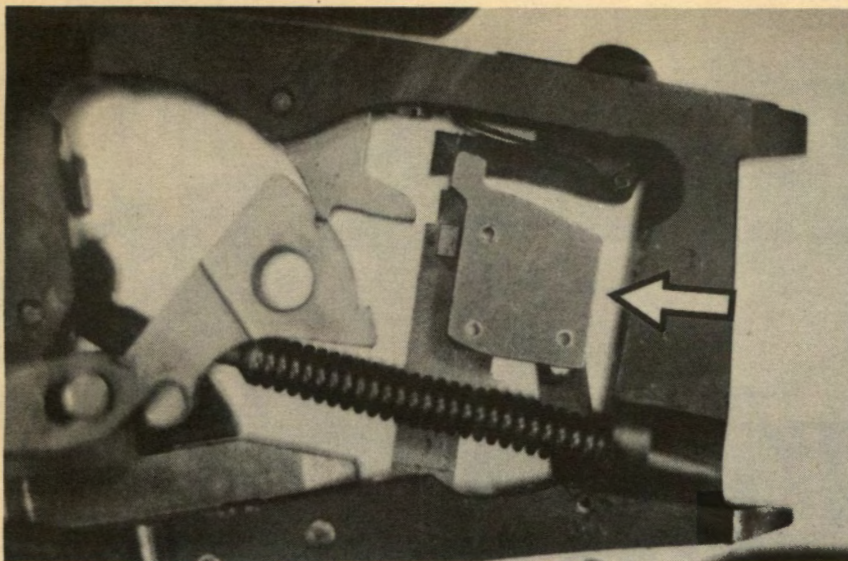
The arrow indicates the inertia block (operated by recoil) which switches the single trigger into contact with the other sear after one barrel has been fired. It is also connected to the safety and is shown in the on-safe position.

The key to the operation of the single trigger is the inertia block, operated by the recoil of the first shot, which switches the trigger into contact with the other sear. The inertia block is also connected to the safety system, and the safety button is also a selector, being moved from one side to the other, determining the barrel to be fired first. The weight, spring ten-

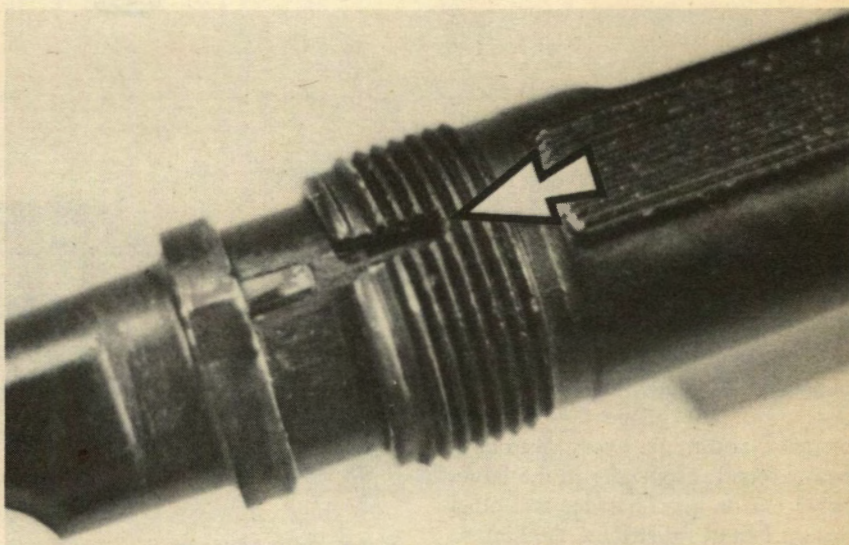
When installing the barrel, be sure the guide rib on the barrel is aligned to enter the guide slot (arrow) on the receiver. If the rib is not aligned, you may damage the gun, severely.

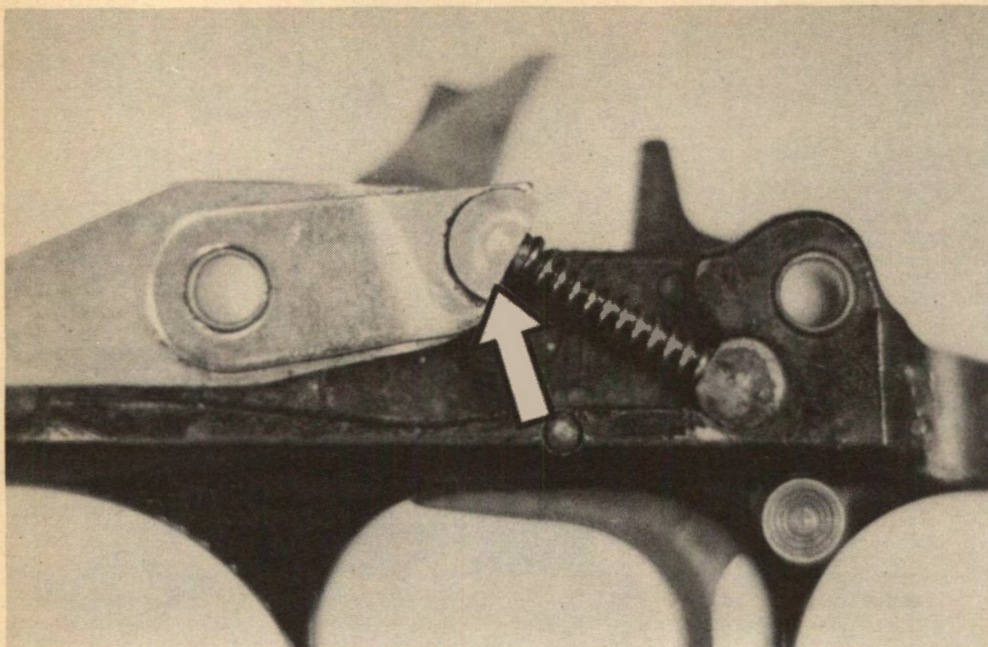
The carrier spring detent (arrow) is a semicircular piece of solid steel with a groove in its curved forward edge which fits the rear arm of the carrier. This part breaks occasionally and is frequently lost in disassembly.

Located on the rear arm of the carrier on the left side of the trigger housing, the carrier spring detent is a small semicircular piece of solid steel with a groove in its curved forward edge which fits against the arm of the carrier. This part is under heavy strain, and I have known them to break, but more often these are lost during amateur disassembly, as the spring can send them quite a distance when they are forced out of position. This part, and all others, are readily available

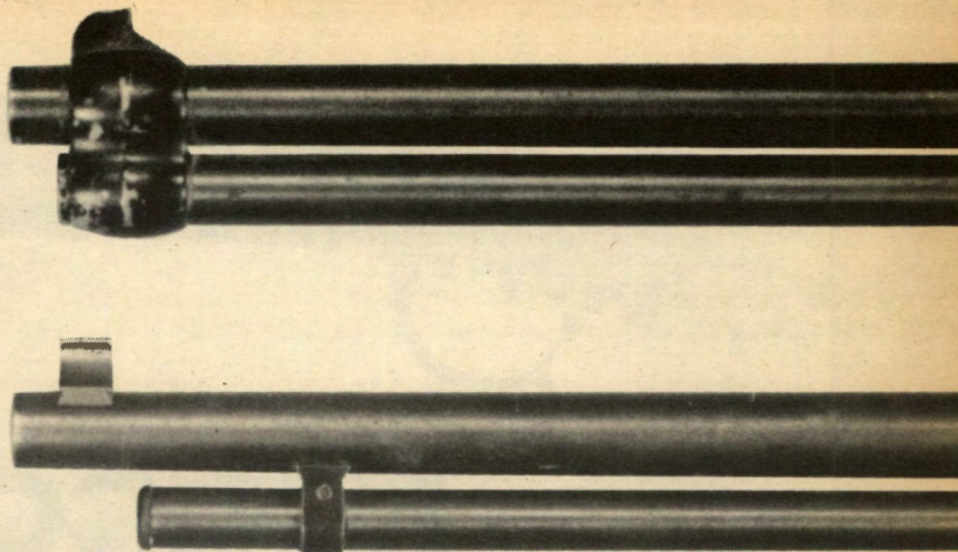
The older Model 49's combination front sight and magazine hanger (top) was made of alloy, retained by one screw, and tended to loosen. The later gun (below) has a much better arrangement.

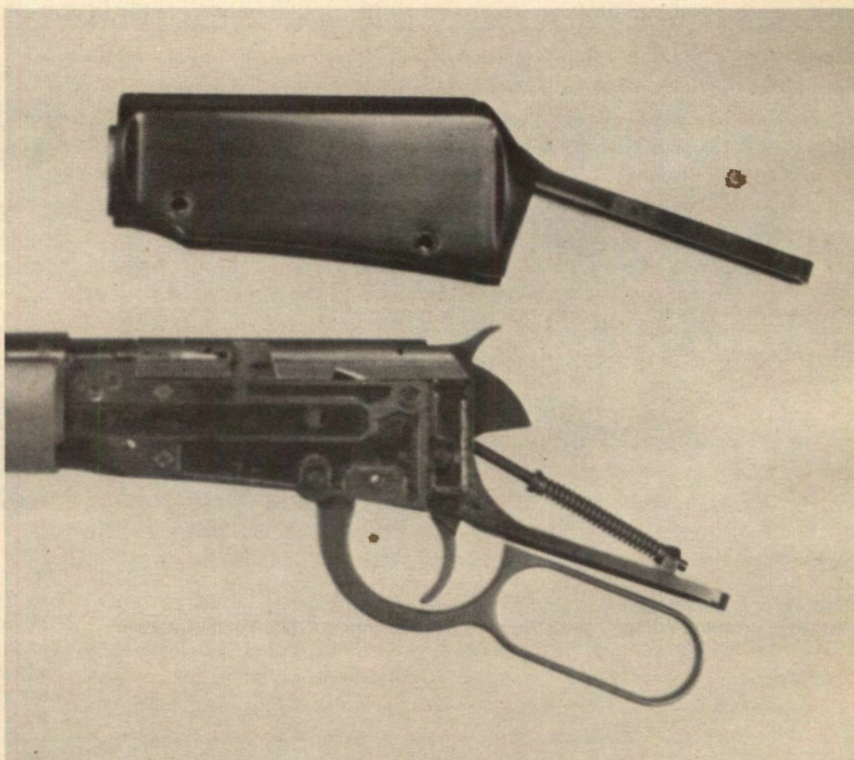
After the stock is taken off, removal of four side screws allows this unusual takedown of the receiver.

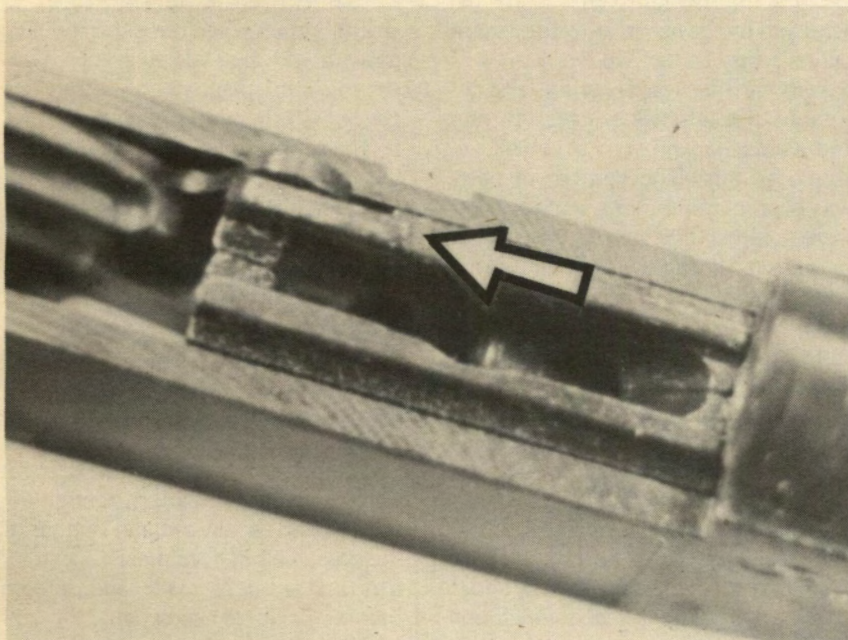
Ejector (arrow) is an integral part of the cartridge guide, and appears to be of ample dimensions to resist breakage and wear.

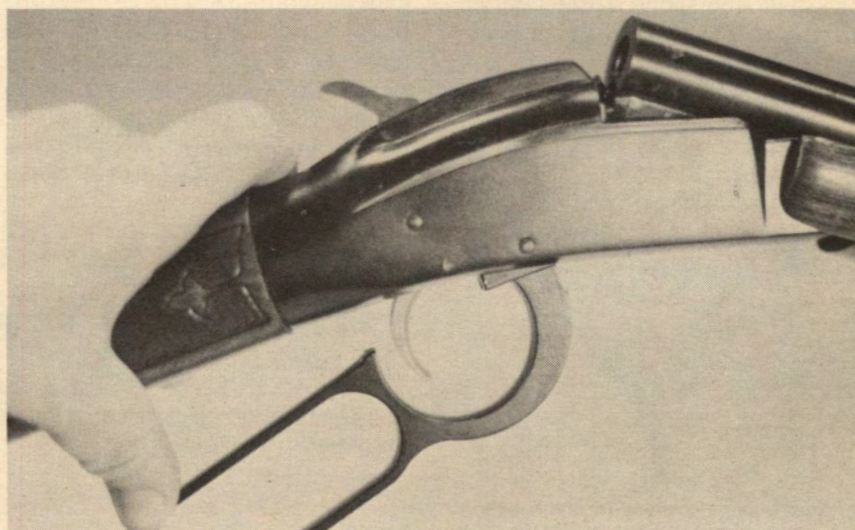
The Model 66 lever is moved only a short distance to release the barrel latch.

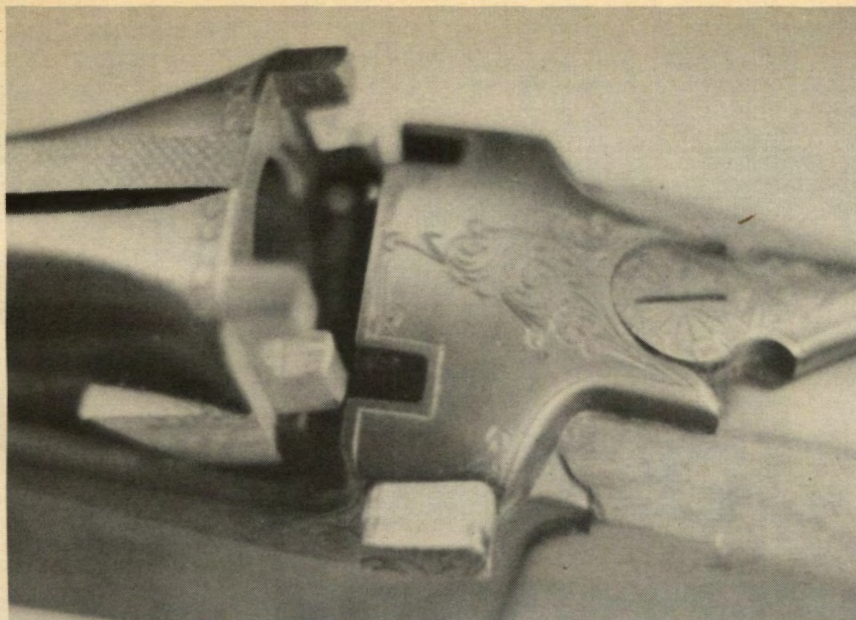
The Model 600 uses a variation of the Greener cross-bolt locking system, and any loosening will be after many years of hard use.

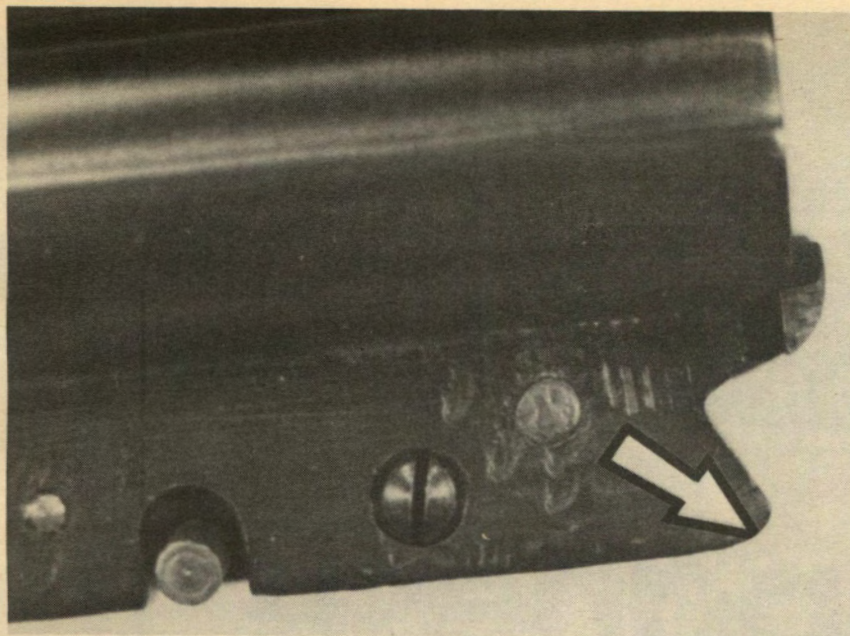
If the wear in the barrel latch system is not too excessive, it can be corrected (most of the time) by using a hammer and screwdriver blade to make a depression below the lip of the lug to raise its upper surface. The arrow shows the location, but this should be done at the center, *not* the edge.

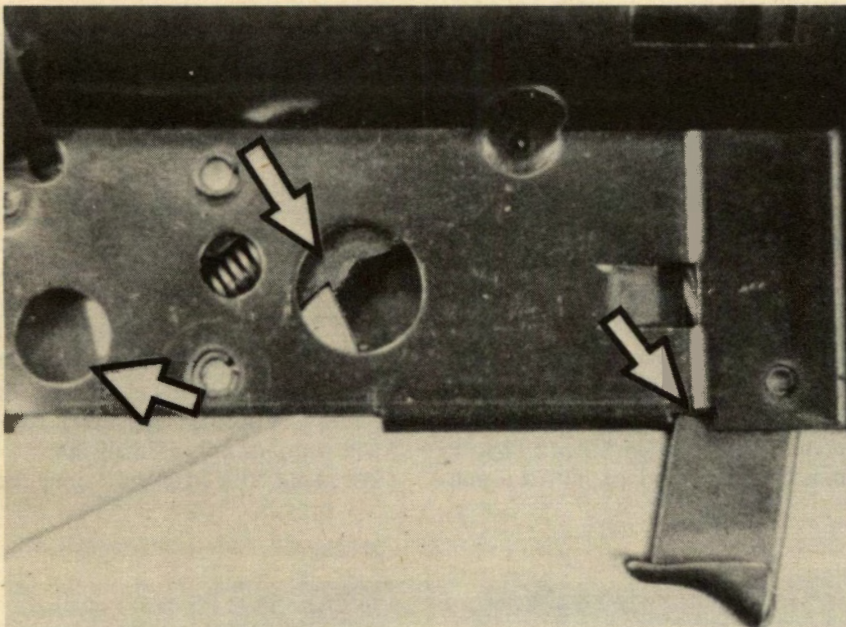
Inspection holes in the trigger housing allow checking of the engagement of the trigger and safety (left arrow), and the sear and trigger (upper arrow). The magazine catch (right arrow) has its own internal flat spring.

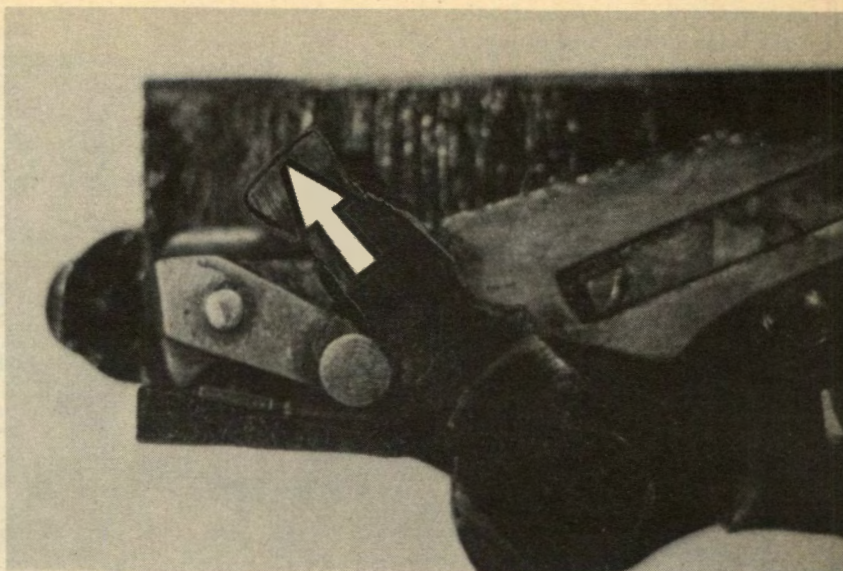
Arrow points to the upper surface of the lever arm which mates with a lower projection on the breech block. When properly joined (in normal operation) they lock the breech block in place.

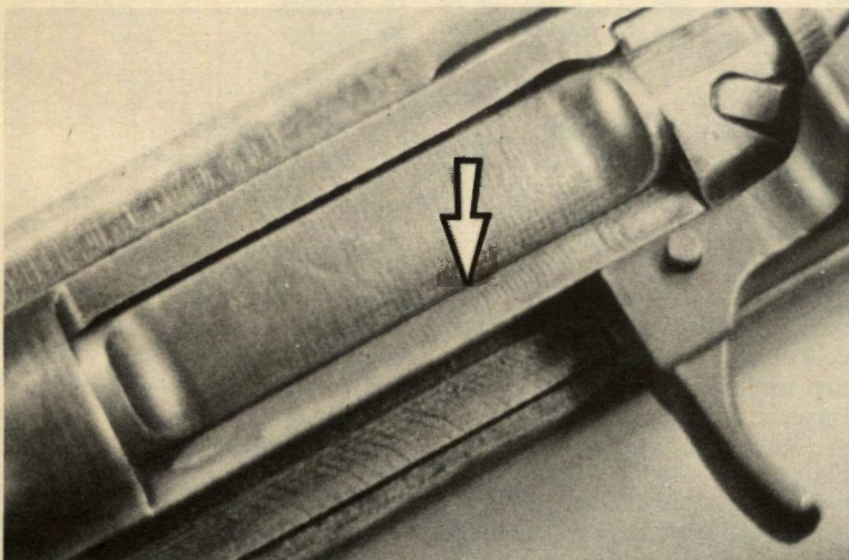
The right receiver rail, which contains the track for the action slide lug (top), is also internally curved to accommodate the bolt (bottom)—as a result, this section of the receiver is understandably quite thin and cracking in this area has been observed.

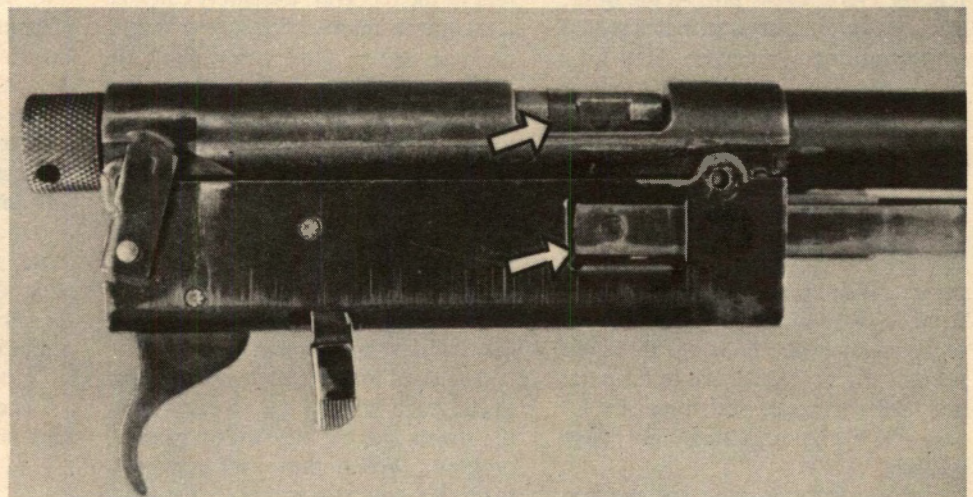
Upper arrow indicates the clip-type double extractor unit. The lower arrow points to the engagement of the slide latch with the slide bar.

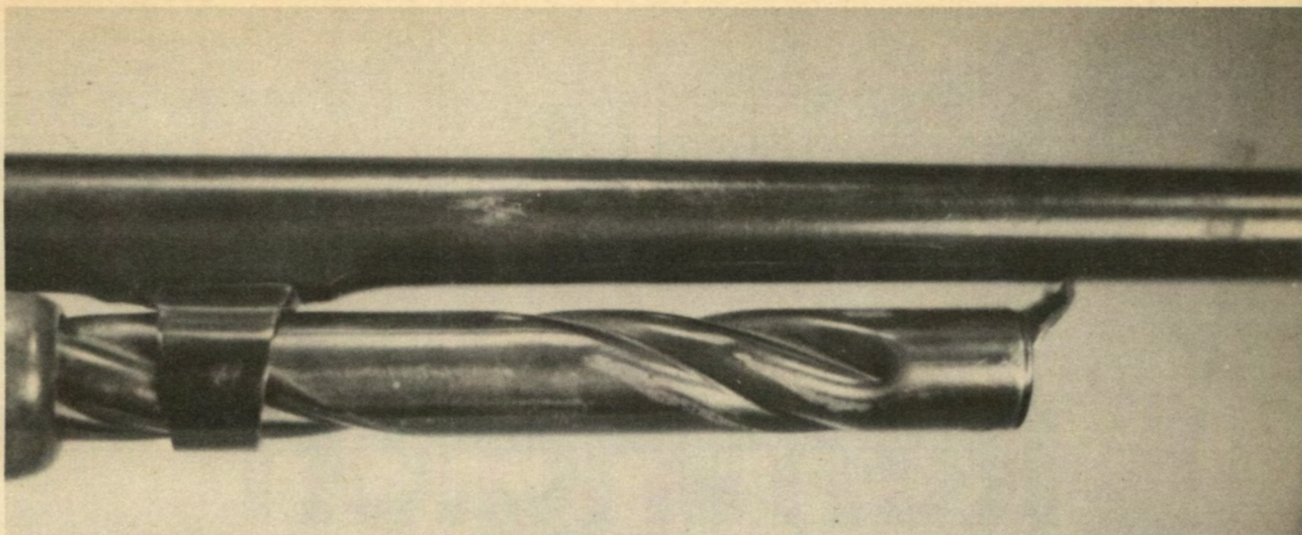
Unique spiral indentations on the magazine of the Model 14 were designed to tip the cartridges, keeping the points of the bullets from resting against the primers of the next rounds in line.

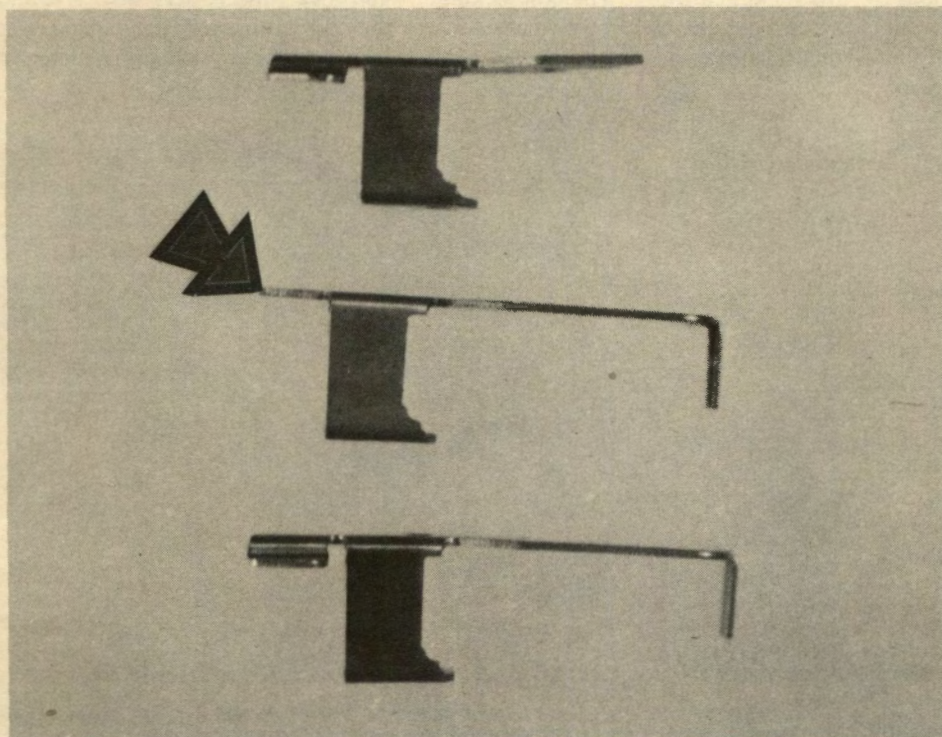
If there is one part on the Nylon 66 that's subject to breakage, it's the disconnector. The one at the top has a broken safety contact extension, while the one in the center has lost its bolt contact lobe (arrow). The disconnector on the bottom is intact.

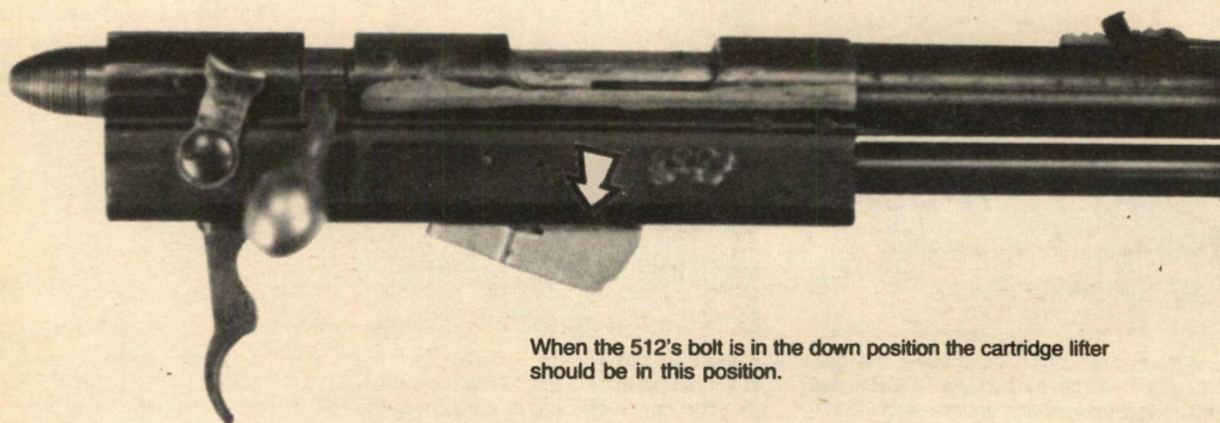
When the 512's bolt is in the down position the cartridge lifter should be in this position.

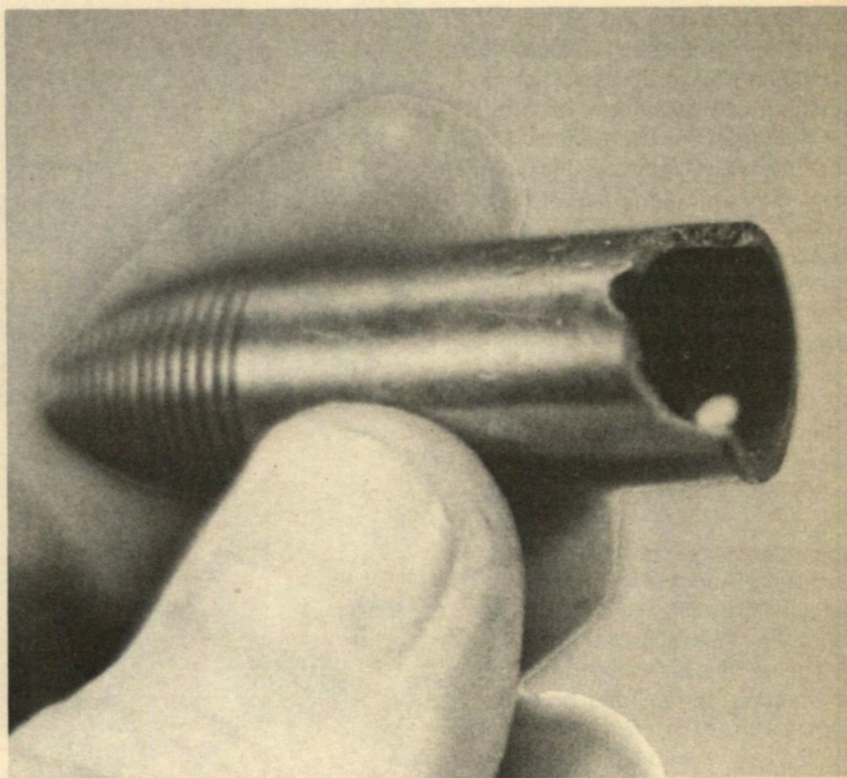
The bolt endpiece of the Remington 512 is hard—so hard that it's brittle. This bolt endpiece was not broken in normal use—it shattered when someone attempted to drive out the cross-pin with a tapered drift.

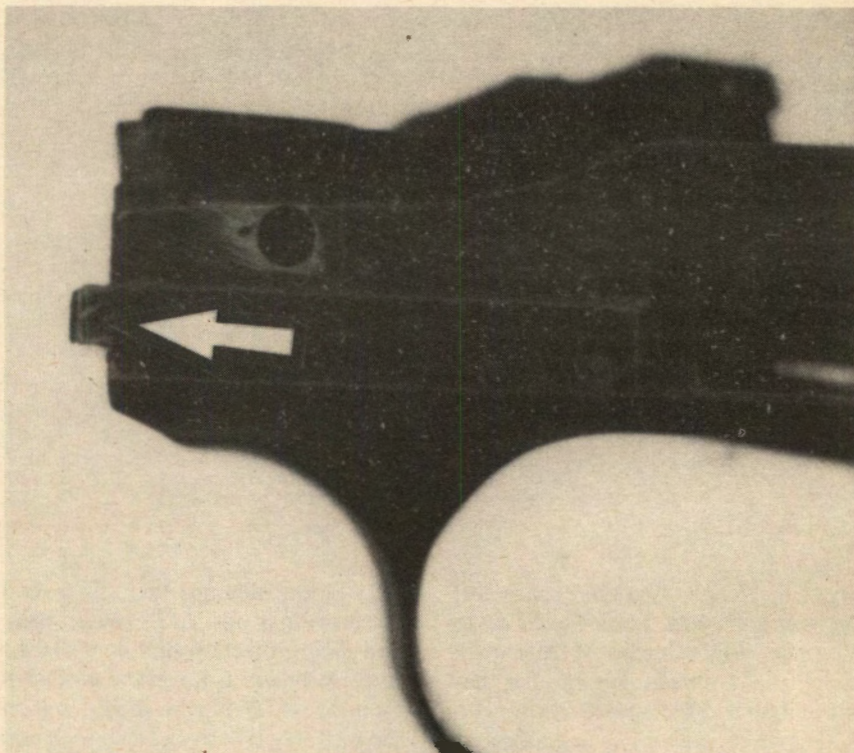
Arrow indicates one of the two opposing retaining lugs found on the forward portion of the trigger group. On the later alloy units, these tend to break off.

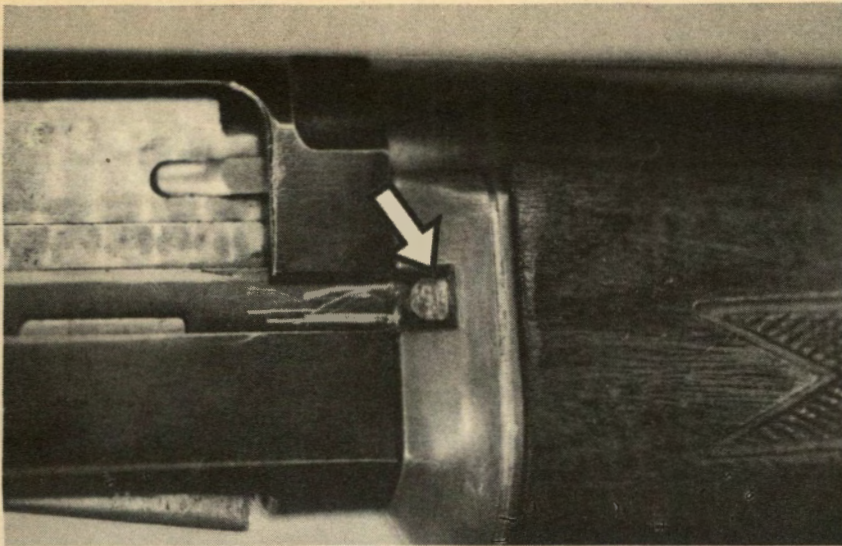
Arrow indicates the location of the bolt cocking handle, broken off on the gun shown. The handle is an integral part of the bar which connects the piston to the locking plate.

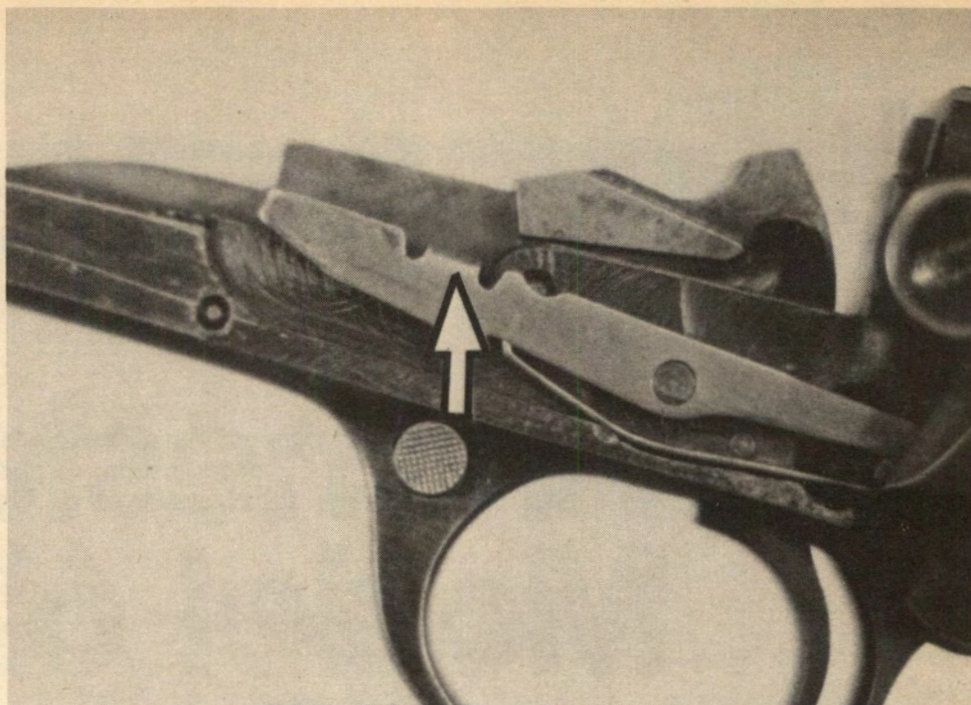
The arrow indicates the engagement of the left lug of the hammer with the slide lock. In this view, the hammer is down, the slide lock depressed.

turned-over shelf at its forward end that is struck by a lug on the left side of the hammer each time the hammer falls, to unlock the action. I have seen one case in which the shelf broke away from the slide lock, and since the factory no longer has this part, it was repaired by welding.

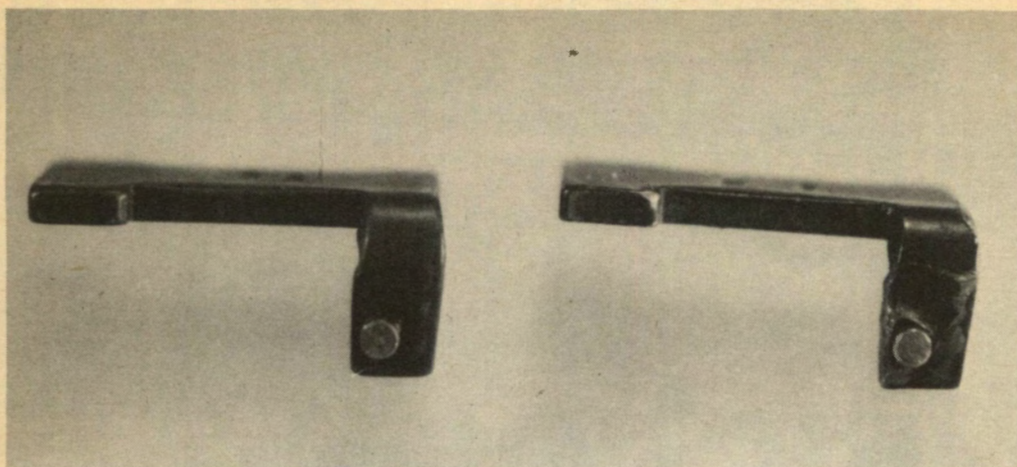
On the left is a new locking plate. To the right is one that has been well used—note how the contact stud has loosened and deformed the lower end of the plate arm.
